**APPENDIX A**

**PHOTOGRAPHS**

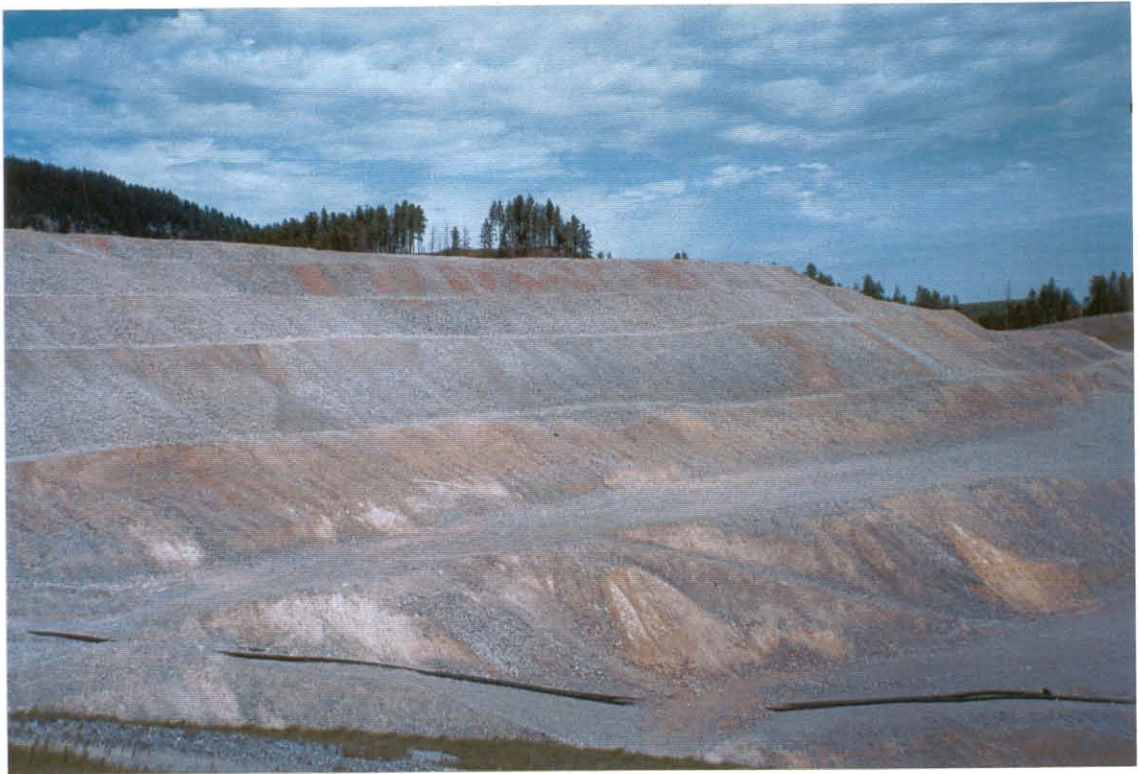
Figure 1. Leach Pad #4. This is one of the areas to be revegetated. The spent ore has a loam texture but contains about 2/3s coarse fragments >2mm. It has some nitrate (approx. 5 ppm) but is severely deficient in P and K. However, with amendment it could serve as a subsoil useful to the deeper-rooting plants, assuming water is present at depth.

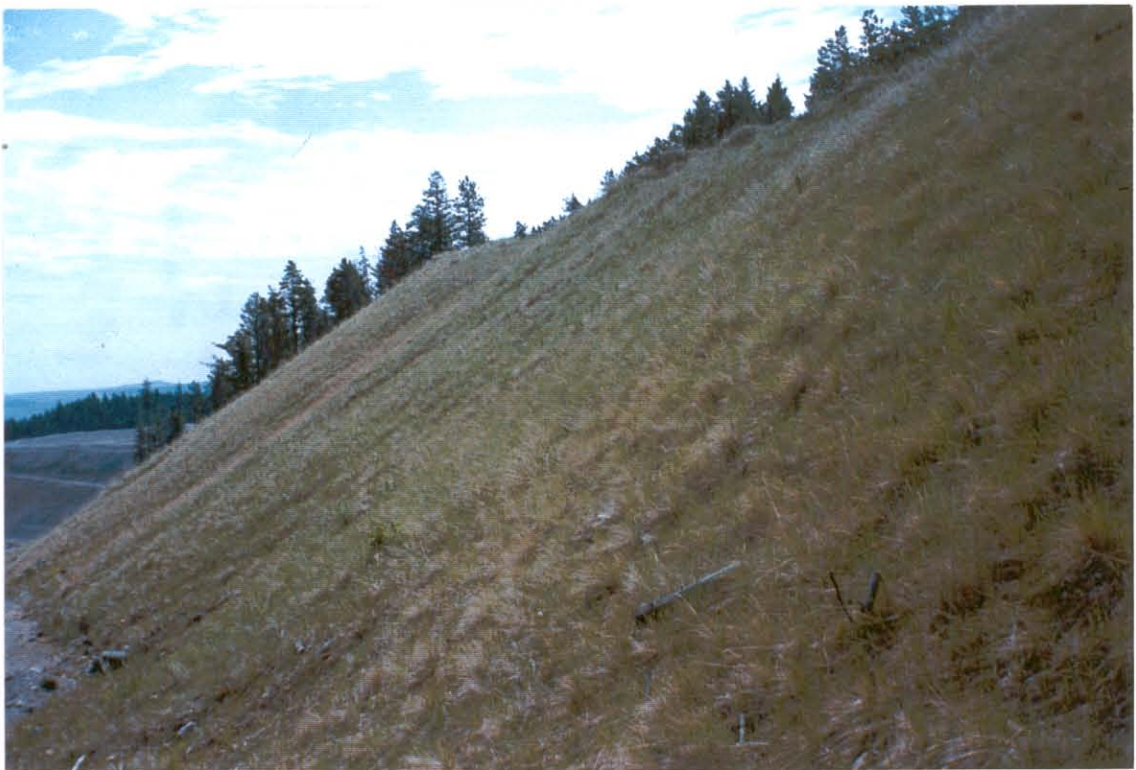
Figure 2. Coversoil stockpile 2a shows that steep-slope revegetation is possible where everything is right: loam texture, 50% coarse fragments, 3% organic matter, thick soil, and decent fertility. This stockpile should be applied to slopes.

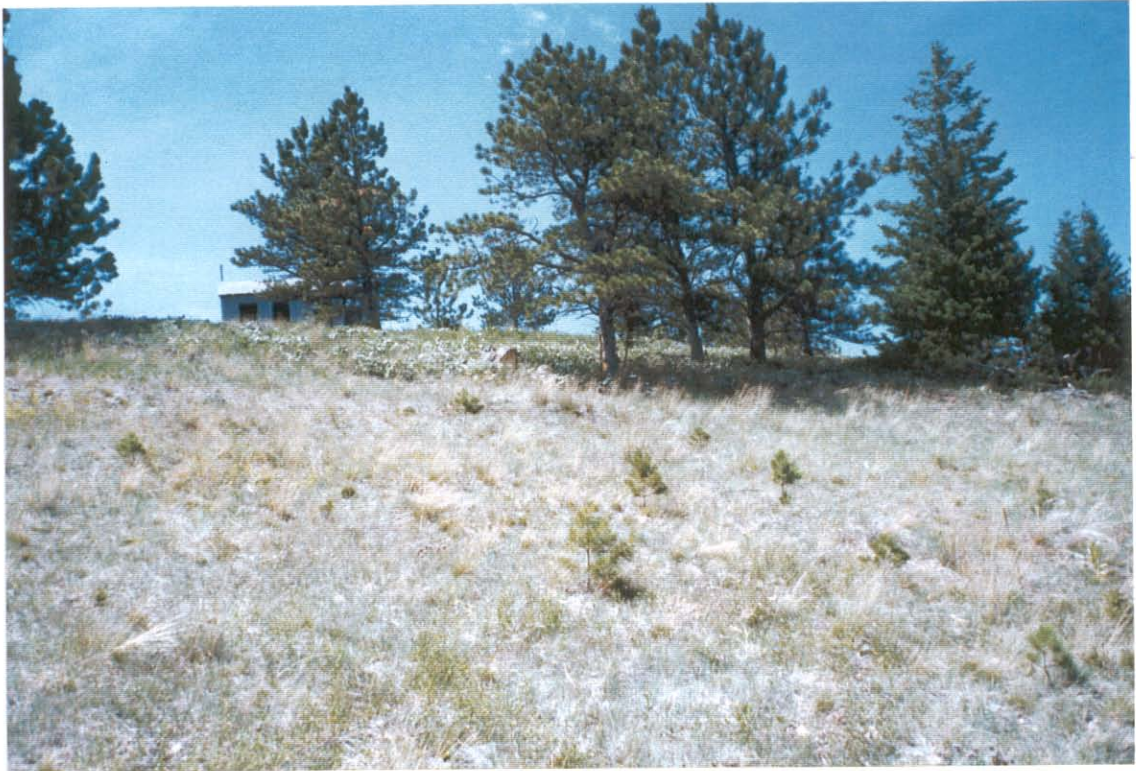
Figure 3. One reference soil is in the cluster of trees shown here; the foreground is the “Muorseshoe” site, where the reclamation cover is influenced by blending into adjacent natural soil. Organic matter in the reference soil is 18% with lots of N, P, and K in the upper six inches. The soil food web is fungi-dominated and indicates good nutrient cycling. The Muorseshoe site has 5% organic matter and a decent soil food web, probably because it is at least partly in-situ material.

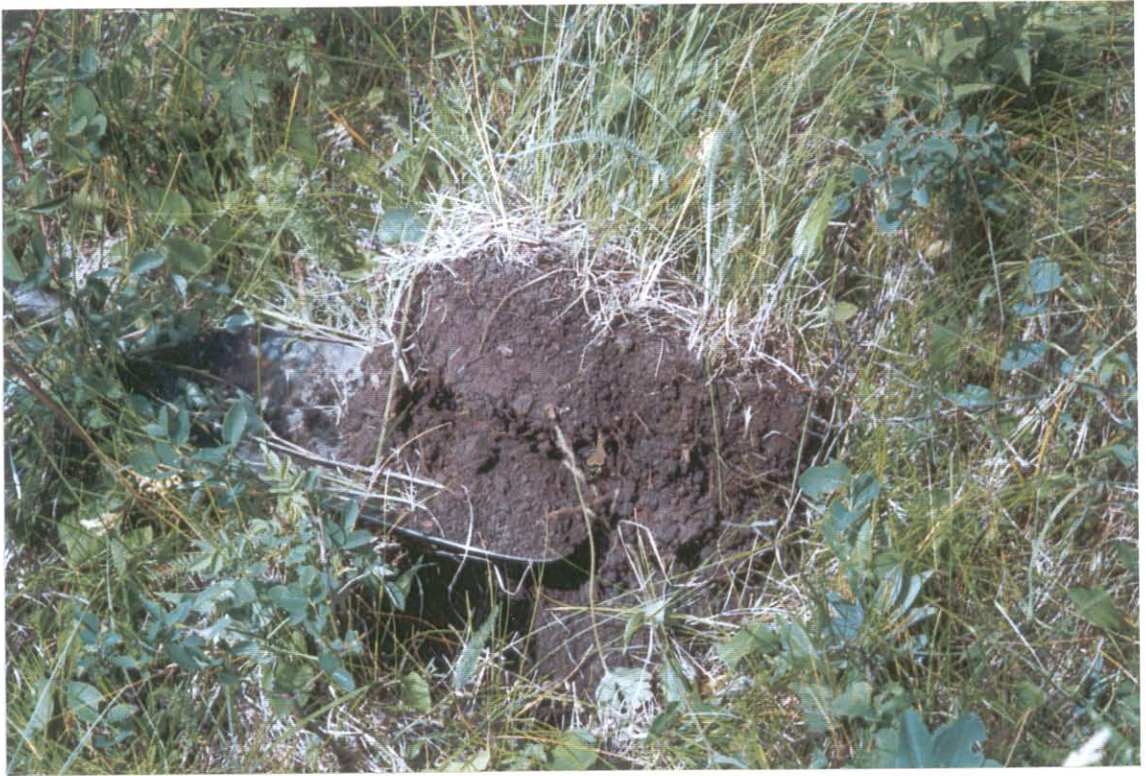
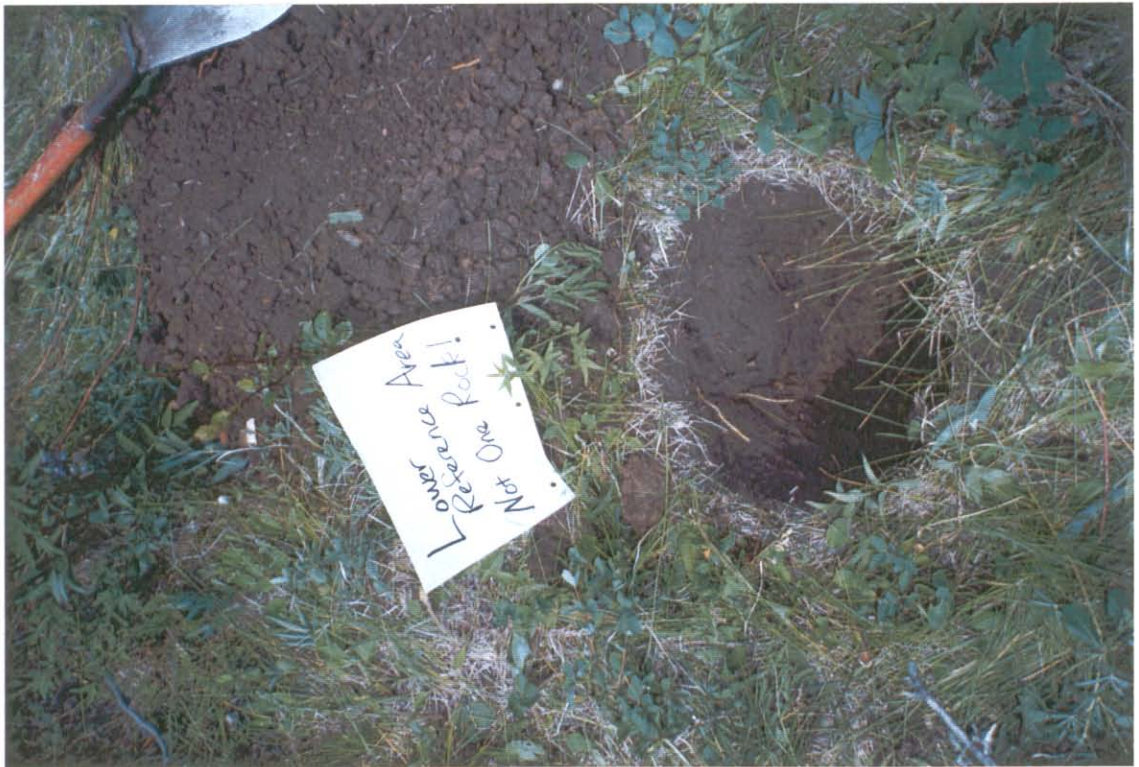
Figure 4. The second (“lower”) reference area is in a diverse thicket of tall shrubs, shorter shrubs, grasses (some sedges), forbs. After chiseling our way through revegetated coversoils, it was refreshing to dig a hole in a soil **WITHOUT ONE ROCK!** But even if we place our best coversoil on gentle slopes, plant communities like this one won’t develop for decades or more if started as grass communities. The upper six inches of this soil has 12% organic matter and is fertile. It was friable with a thick mass of roots.

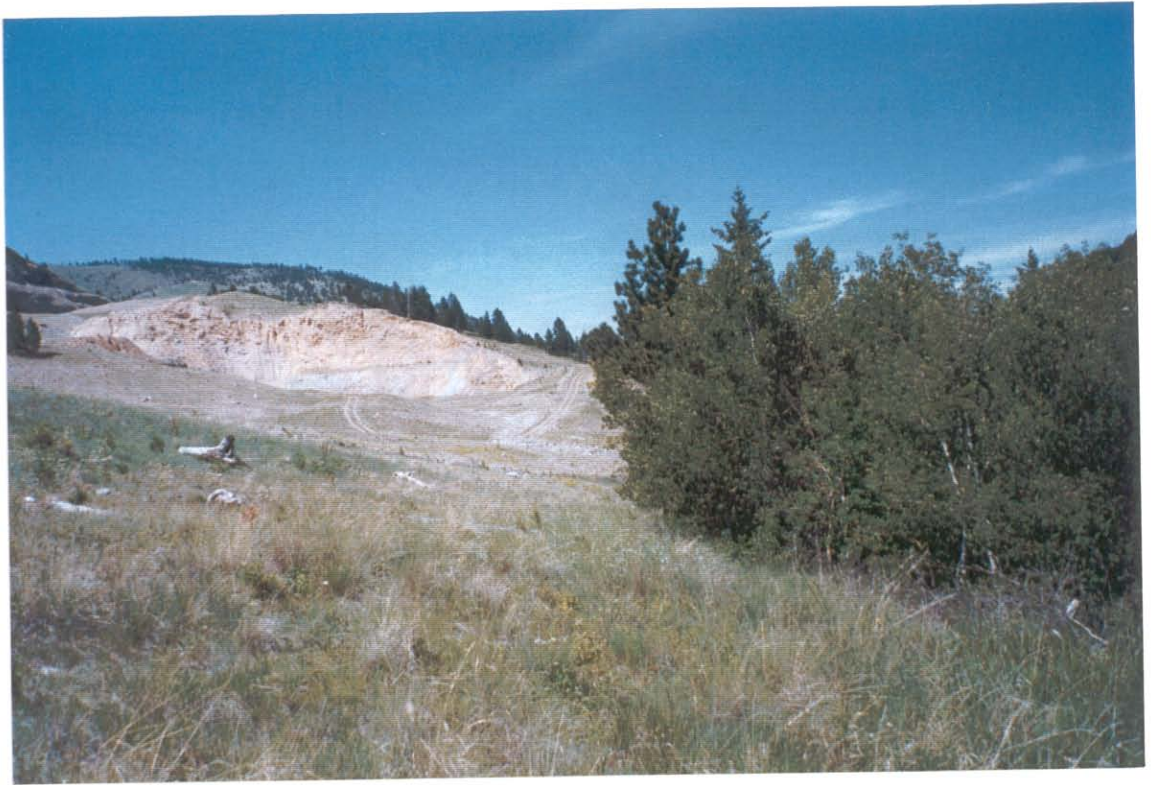
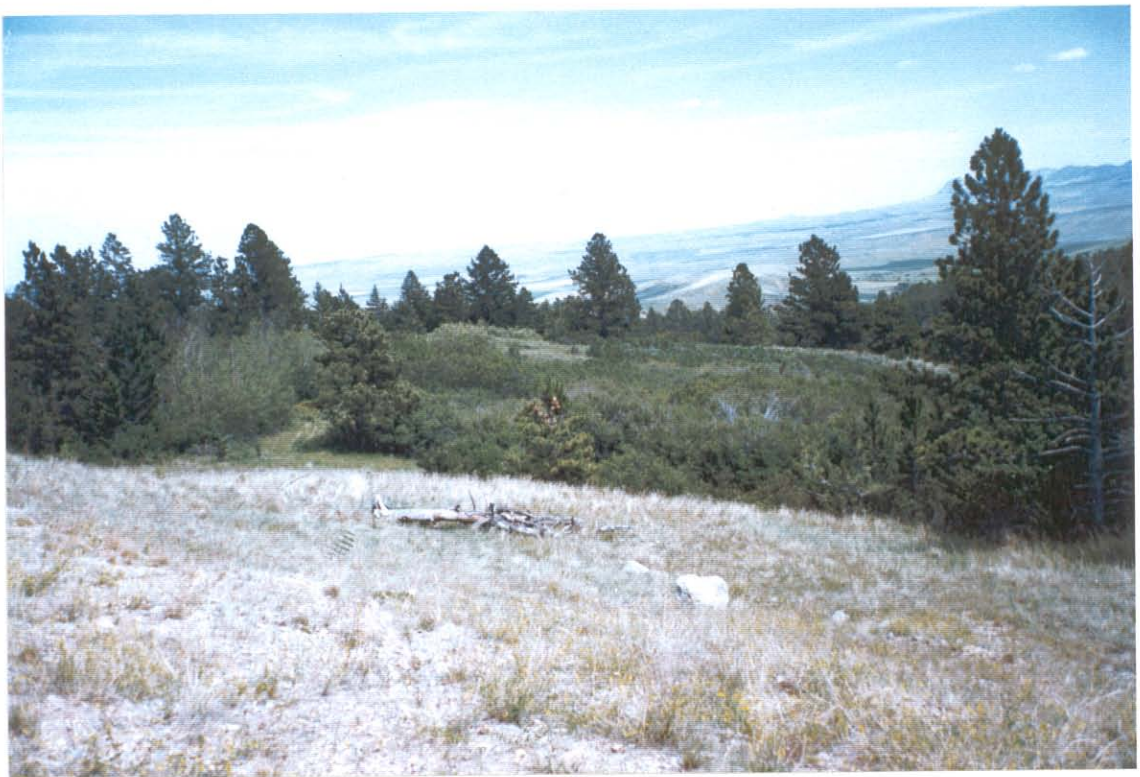
Figure 5. The contrast between revegetation and premine vegetation is stark. The single factor that could have done most to improve revegetation prospects would have been to save the topsoil in two lifts, separating A + B material from underlying horizons. (Lower photo shows the lower reference site.) It remains for us to do the best we can with the resources available.
